FLOOD PLAIN MANAGEMENT

#b A STUDY OF BRIERY BRANCH
including a portion of NORTH RIVER
and MOSSY CREEK

September 1984

A Study of Briery Branch and a portion of North River and Mossy Creek Rockingham County, Virginia

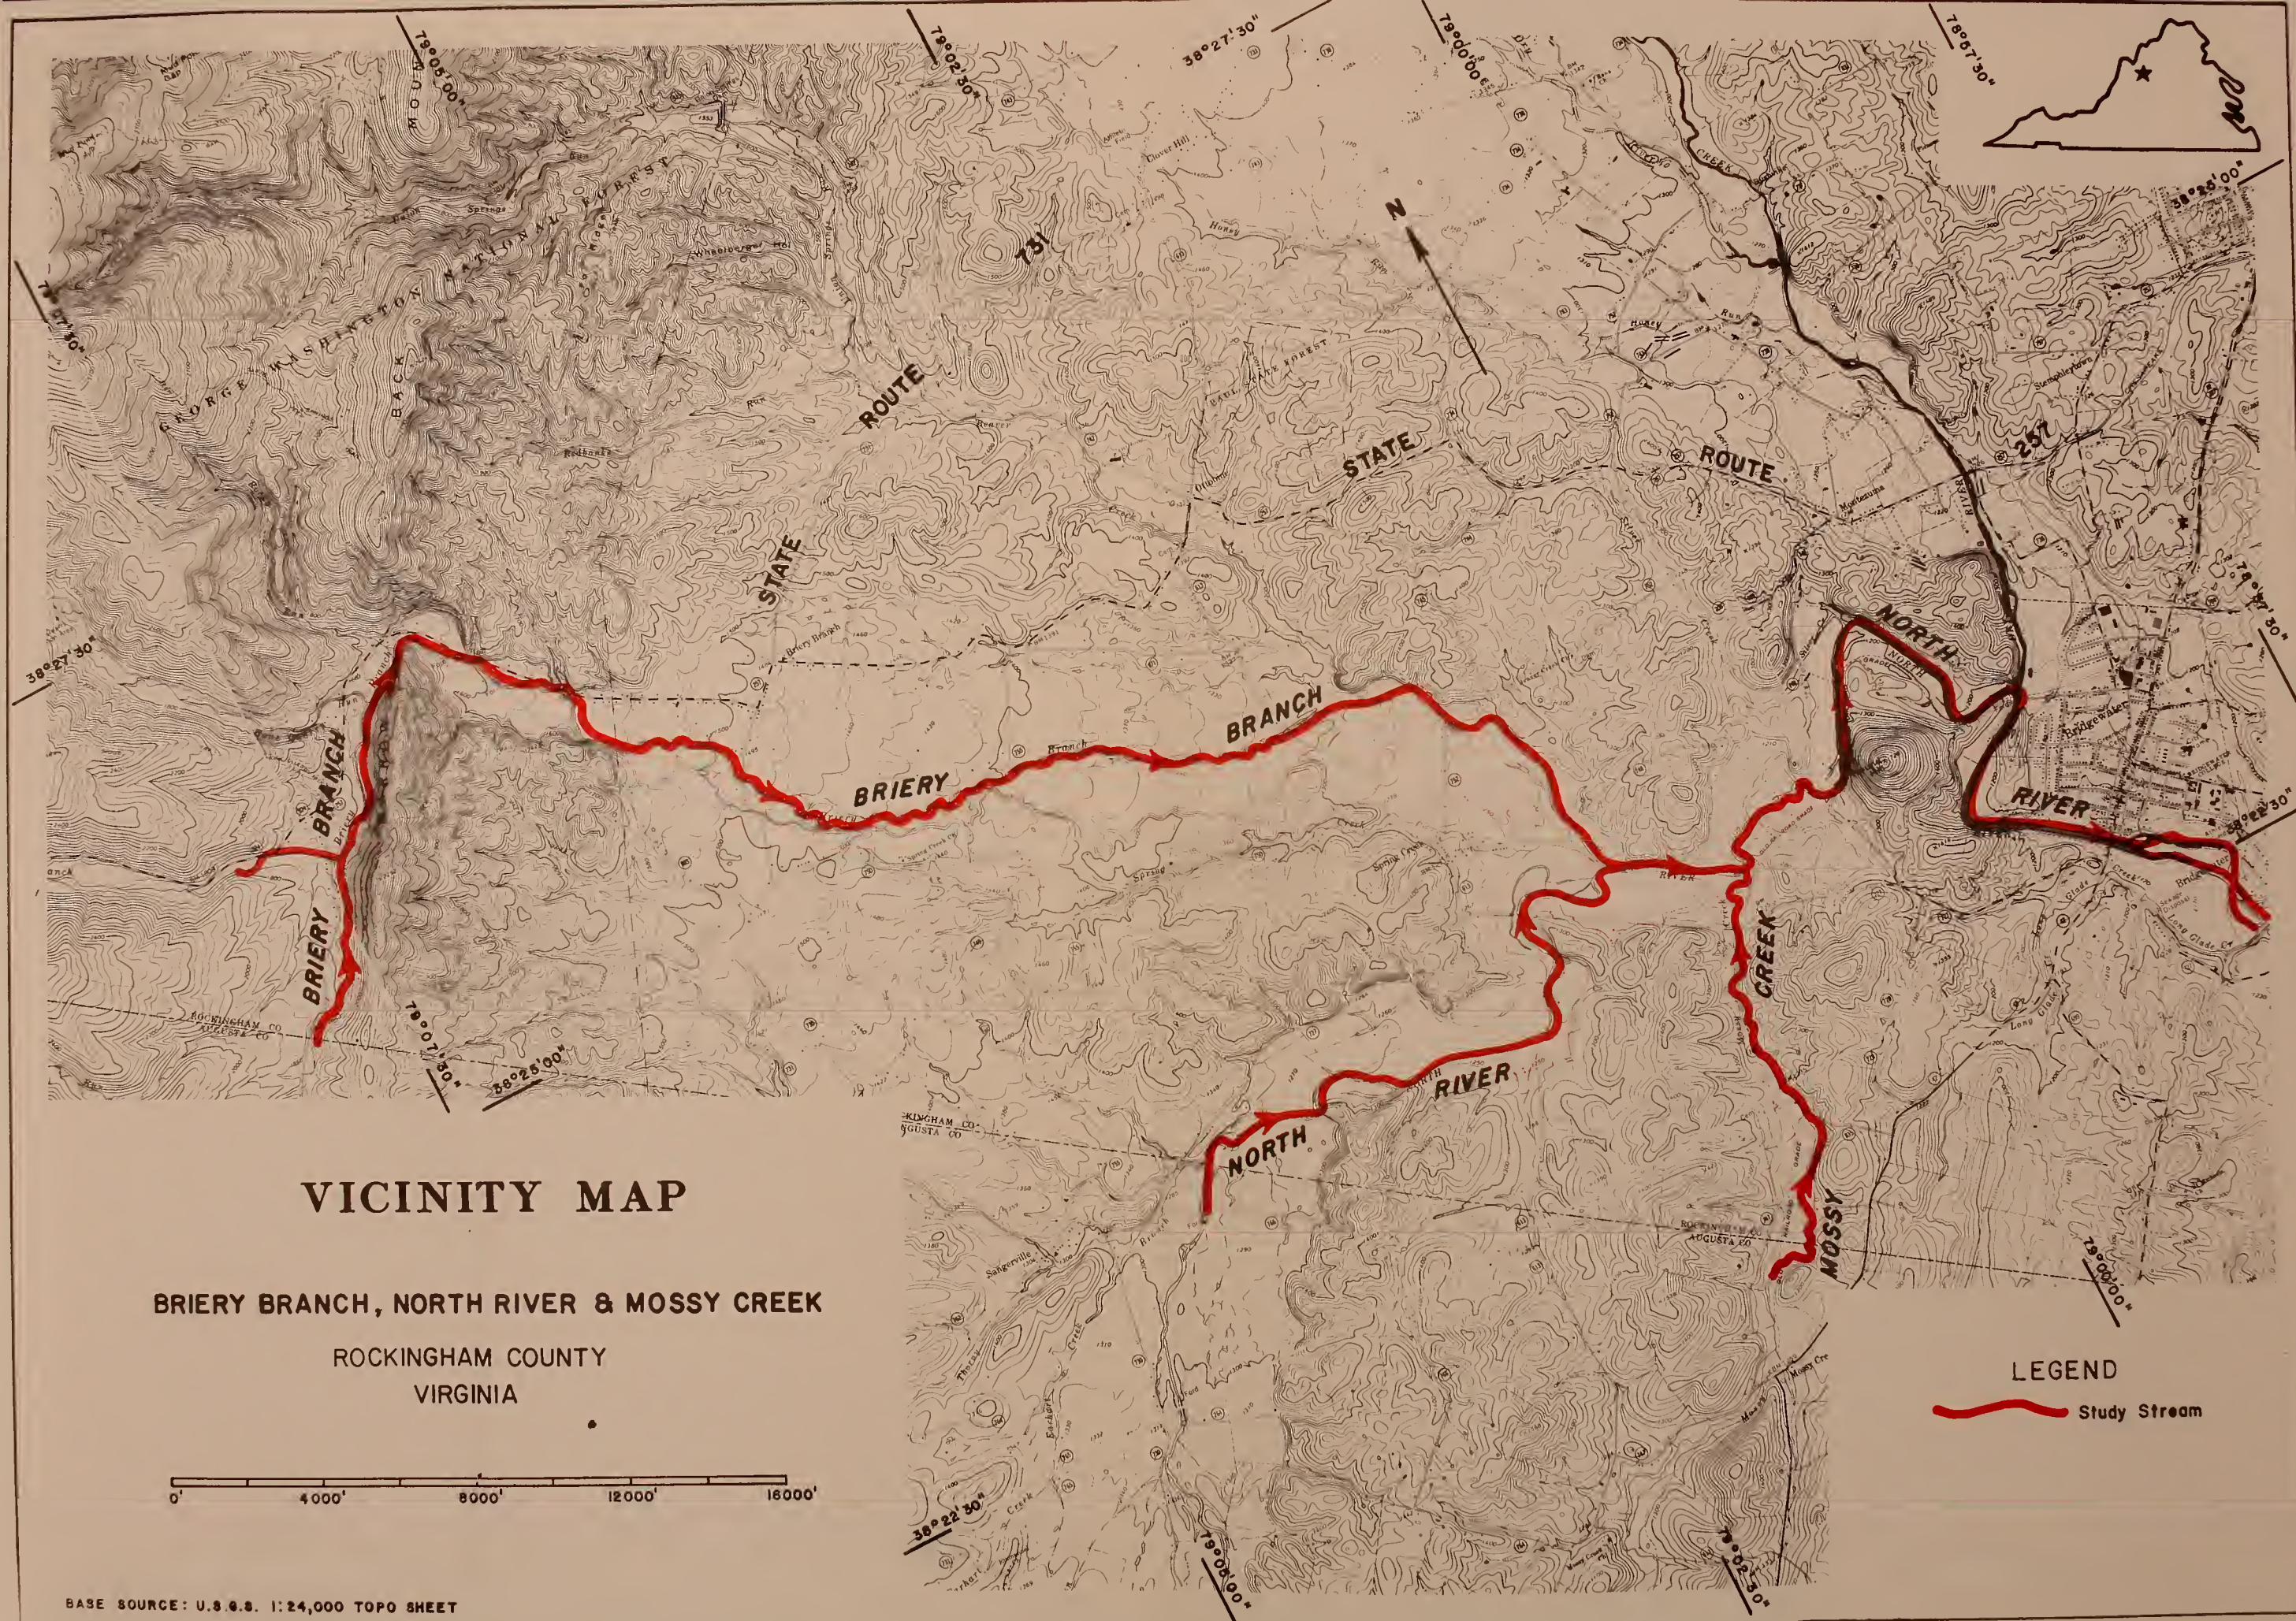
VICINITY MAP

BRIERY BRANCH, NORTH RIVER & MOSSY CREEK

ROCKINGHAM COUNTY
VIRGINIA

The study area comprises 179.24 square miles. Over half of the drainage area is in neighboring Augusta County (Figure 1). North River is a subbasin of the Potomac River Basin which is in Mid-Atlantic Region as designated by the Water Resources Council. The USGS Hydrologic Unit code number in the area is 02070005.

A total of approximately 15.9 stream miles were studied. This included 2.0 miles along Mossy Creek; 6.7 miles of North River; and 7.2 miles of Briery Branch (see Figure 1).

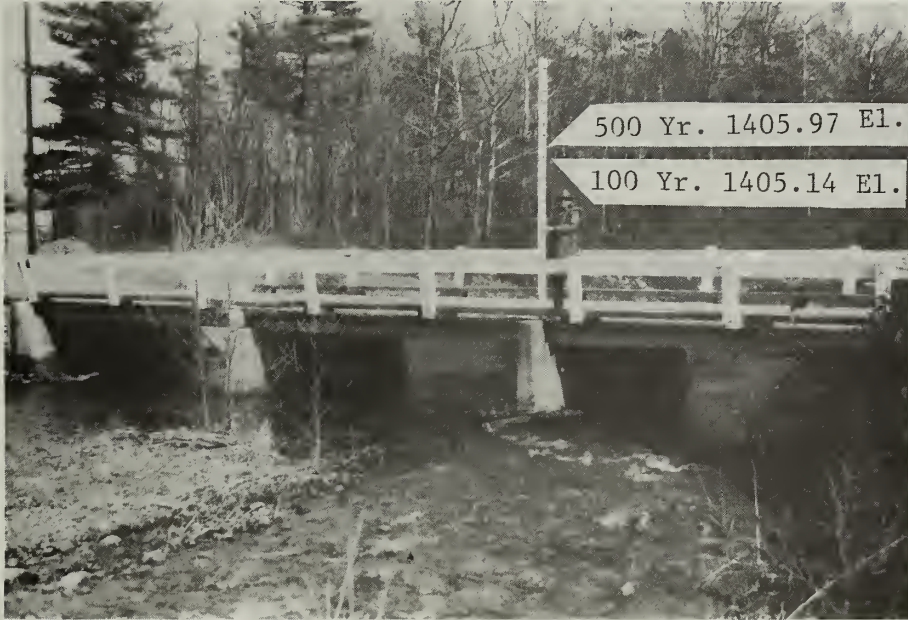
Figure 2. State Route 755 crossing Briery Branch northeast of Spring Creek Church. (At cross section BB83)

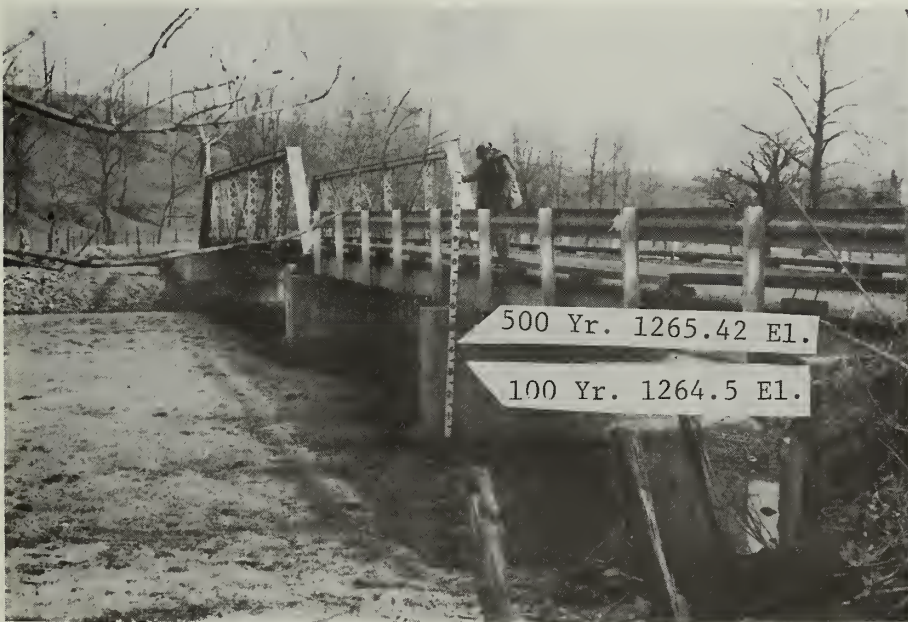
Figure 3. State Route 752 crossing Briery Branch west of Beaver Creek Church. (At cross section BB94)

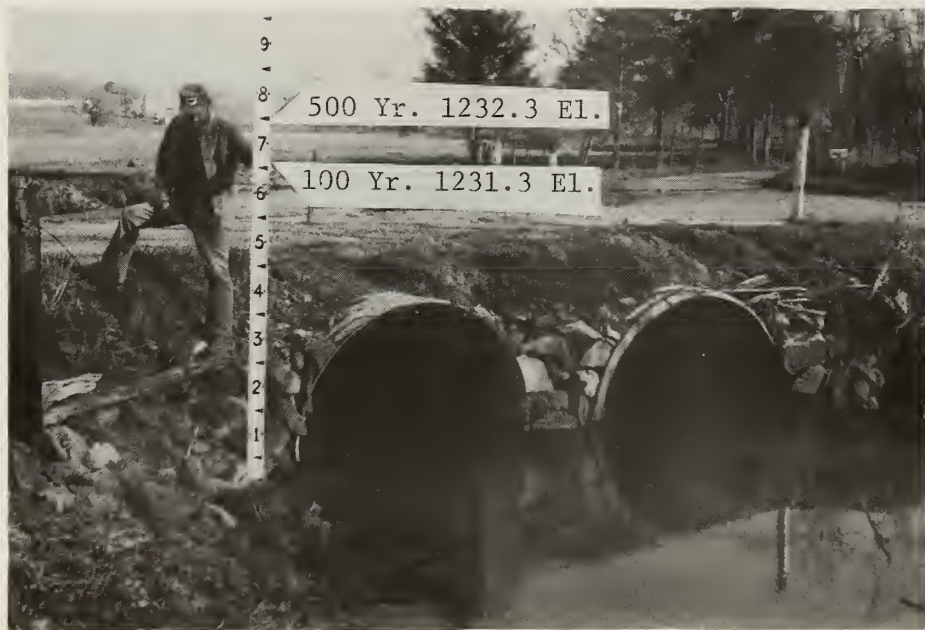
Figure 4. Mossy Creek looking across State Route 747 near junction with State Route 835. (At cross section MC94)

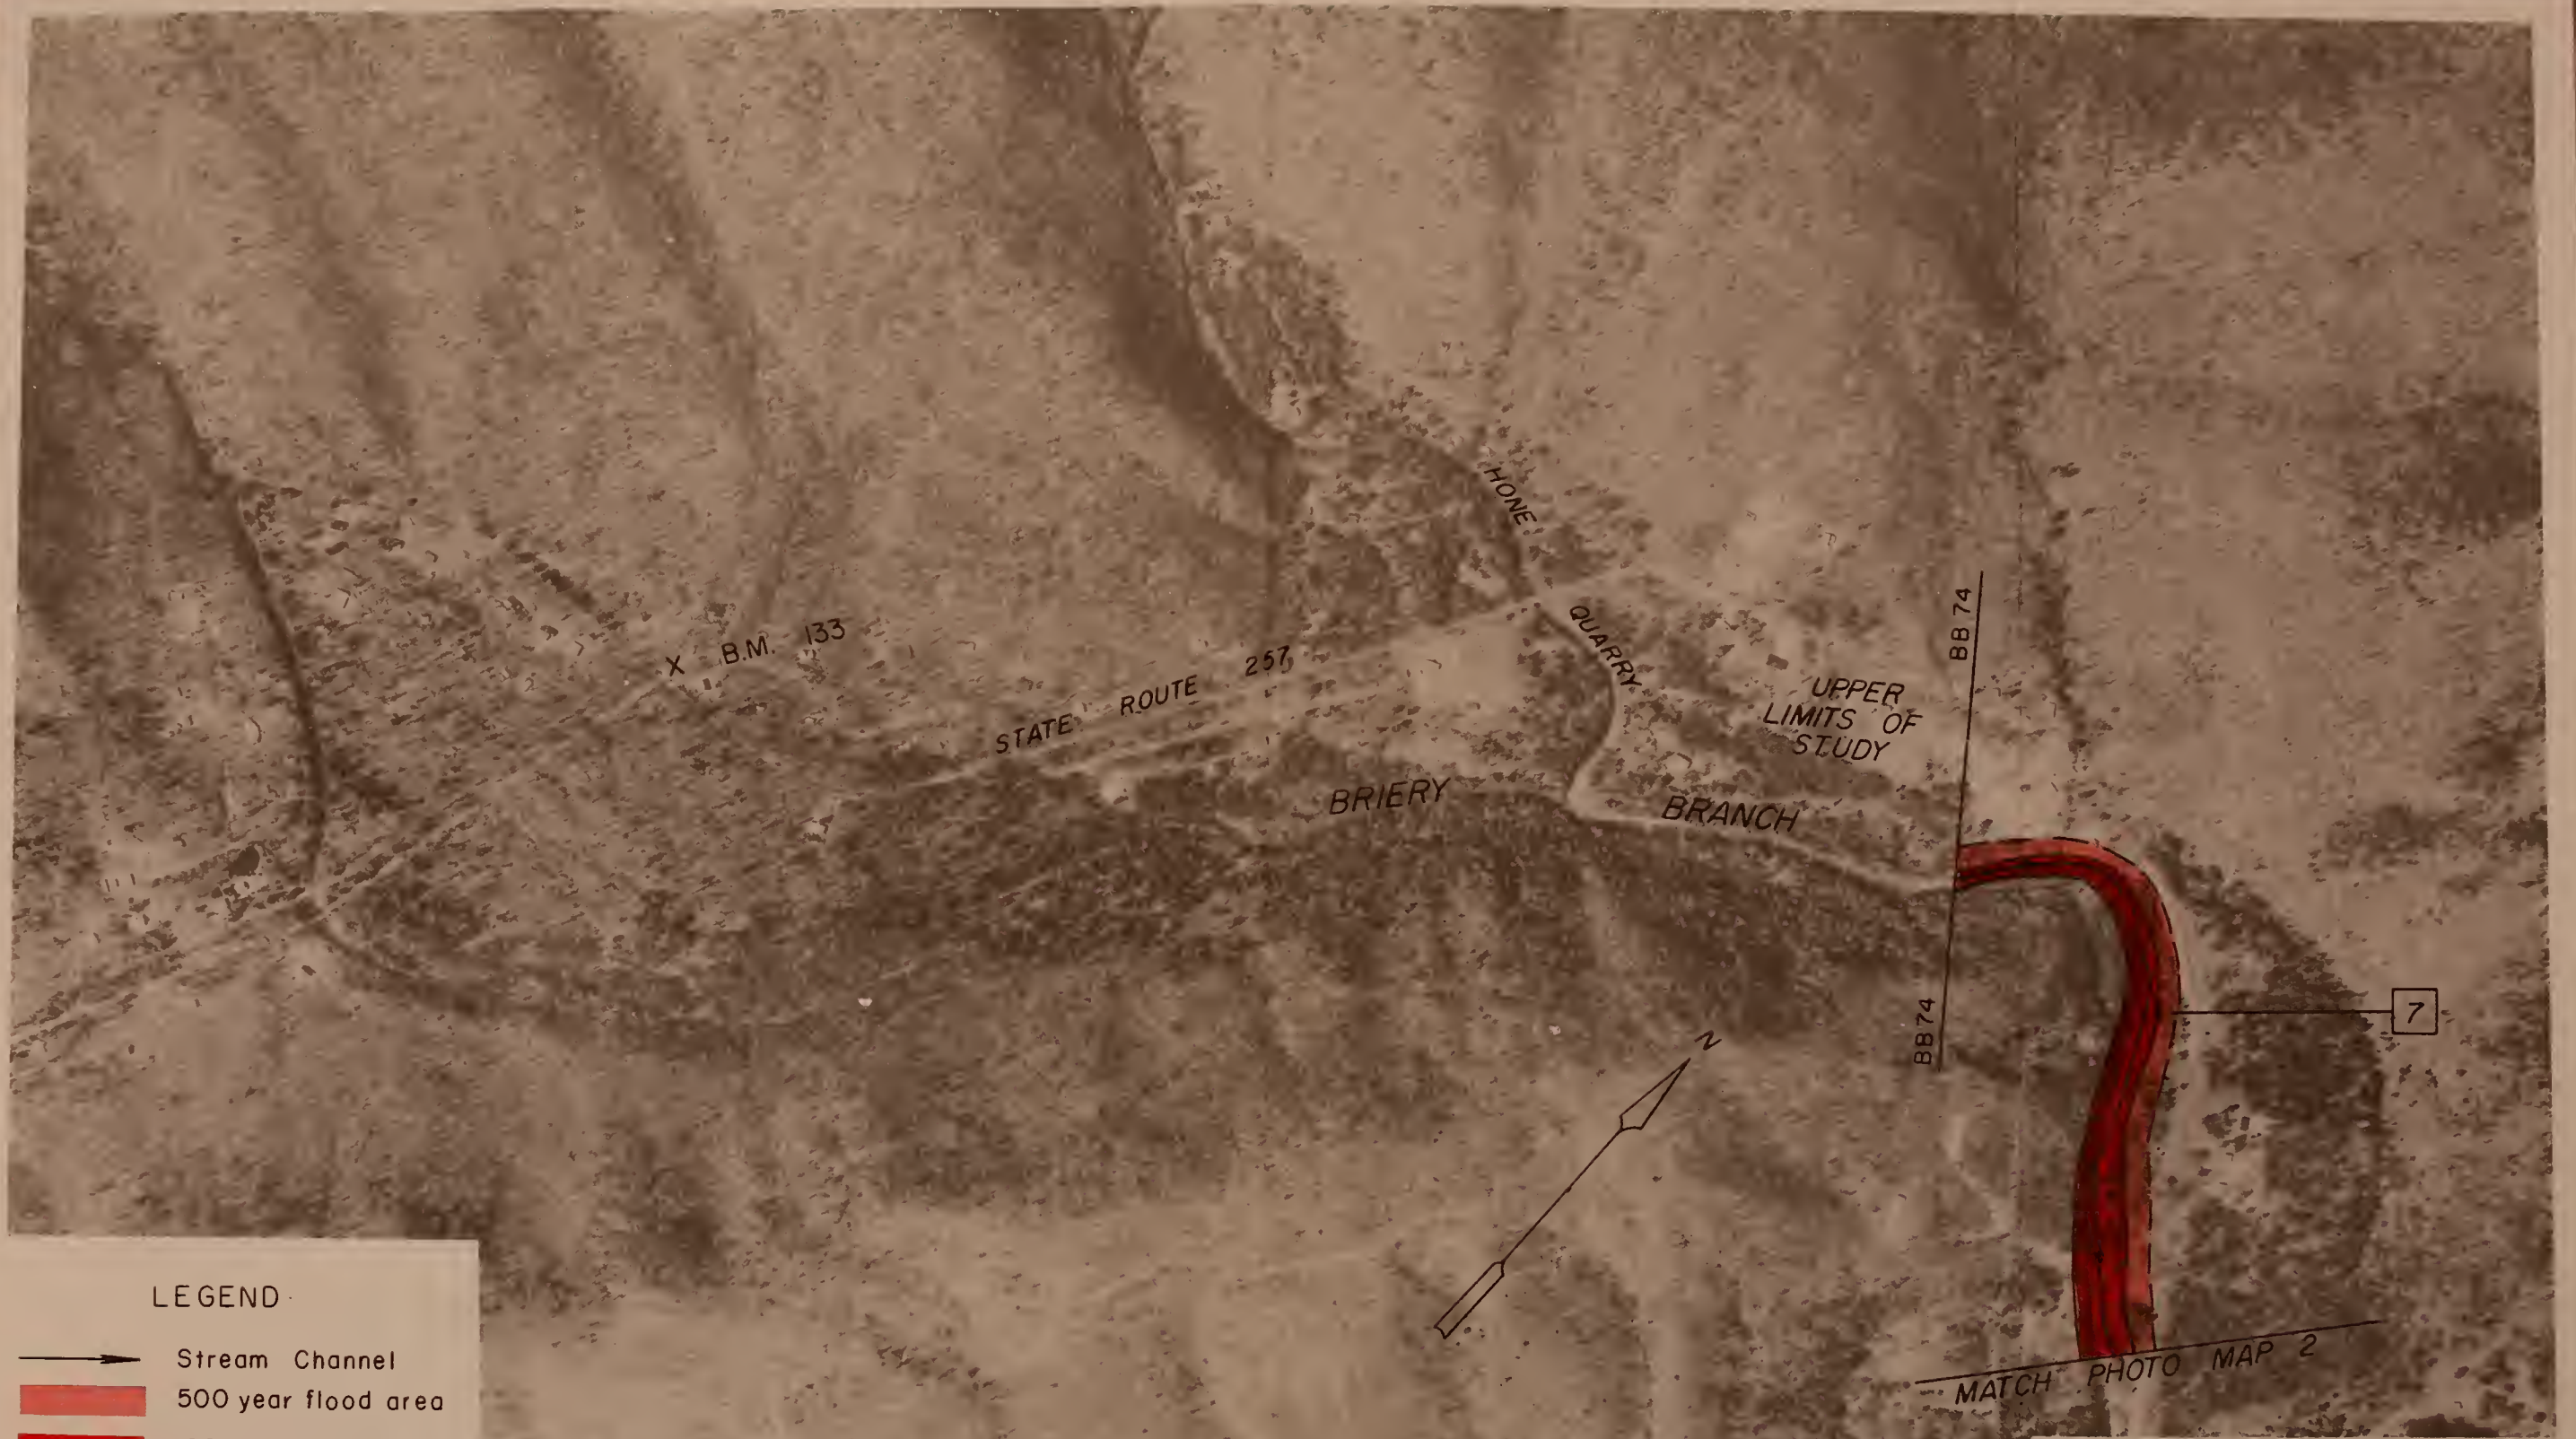
FLOOD HAZARD AREAS BRIERY BRANCH ROCKINGHAM COUNTY,VIRGINIA U.S. DEPARTMENT OF AGRICULTURE SOIL CONSERVATION SERVICE	
Date _____	
Designed _____	
Drawn _____	
Traced _____	
Checked _____	
SHEET 1 OF 11

Flood plain photomaps show the area covered by the 100- and 500-year floods. Where only one line is shown, there is no difference in the boundary of the two flood areas. These photomaps should be used to determine approximate flood elevations.

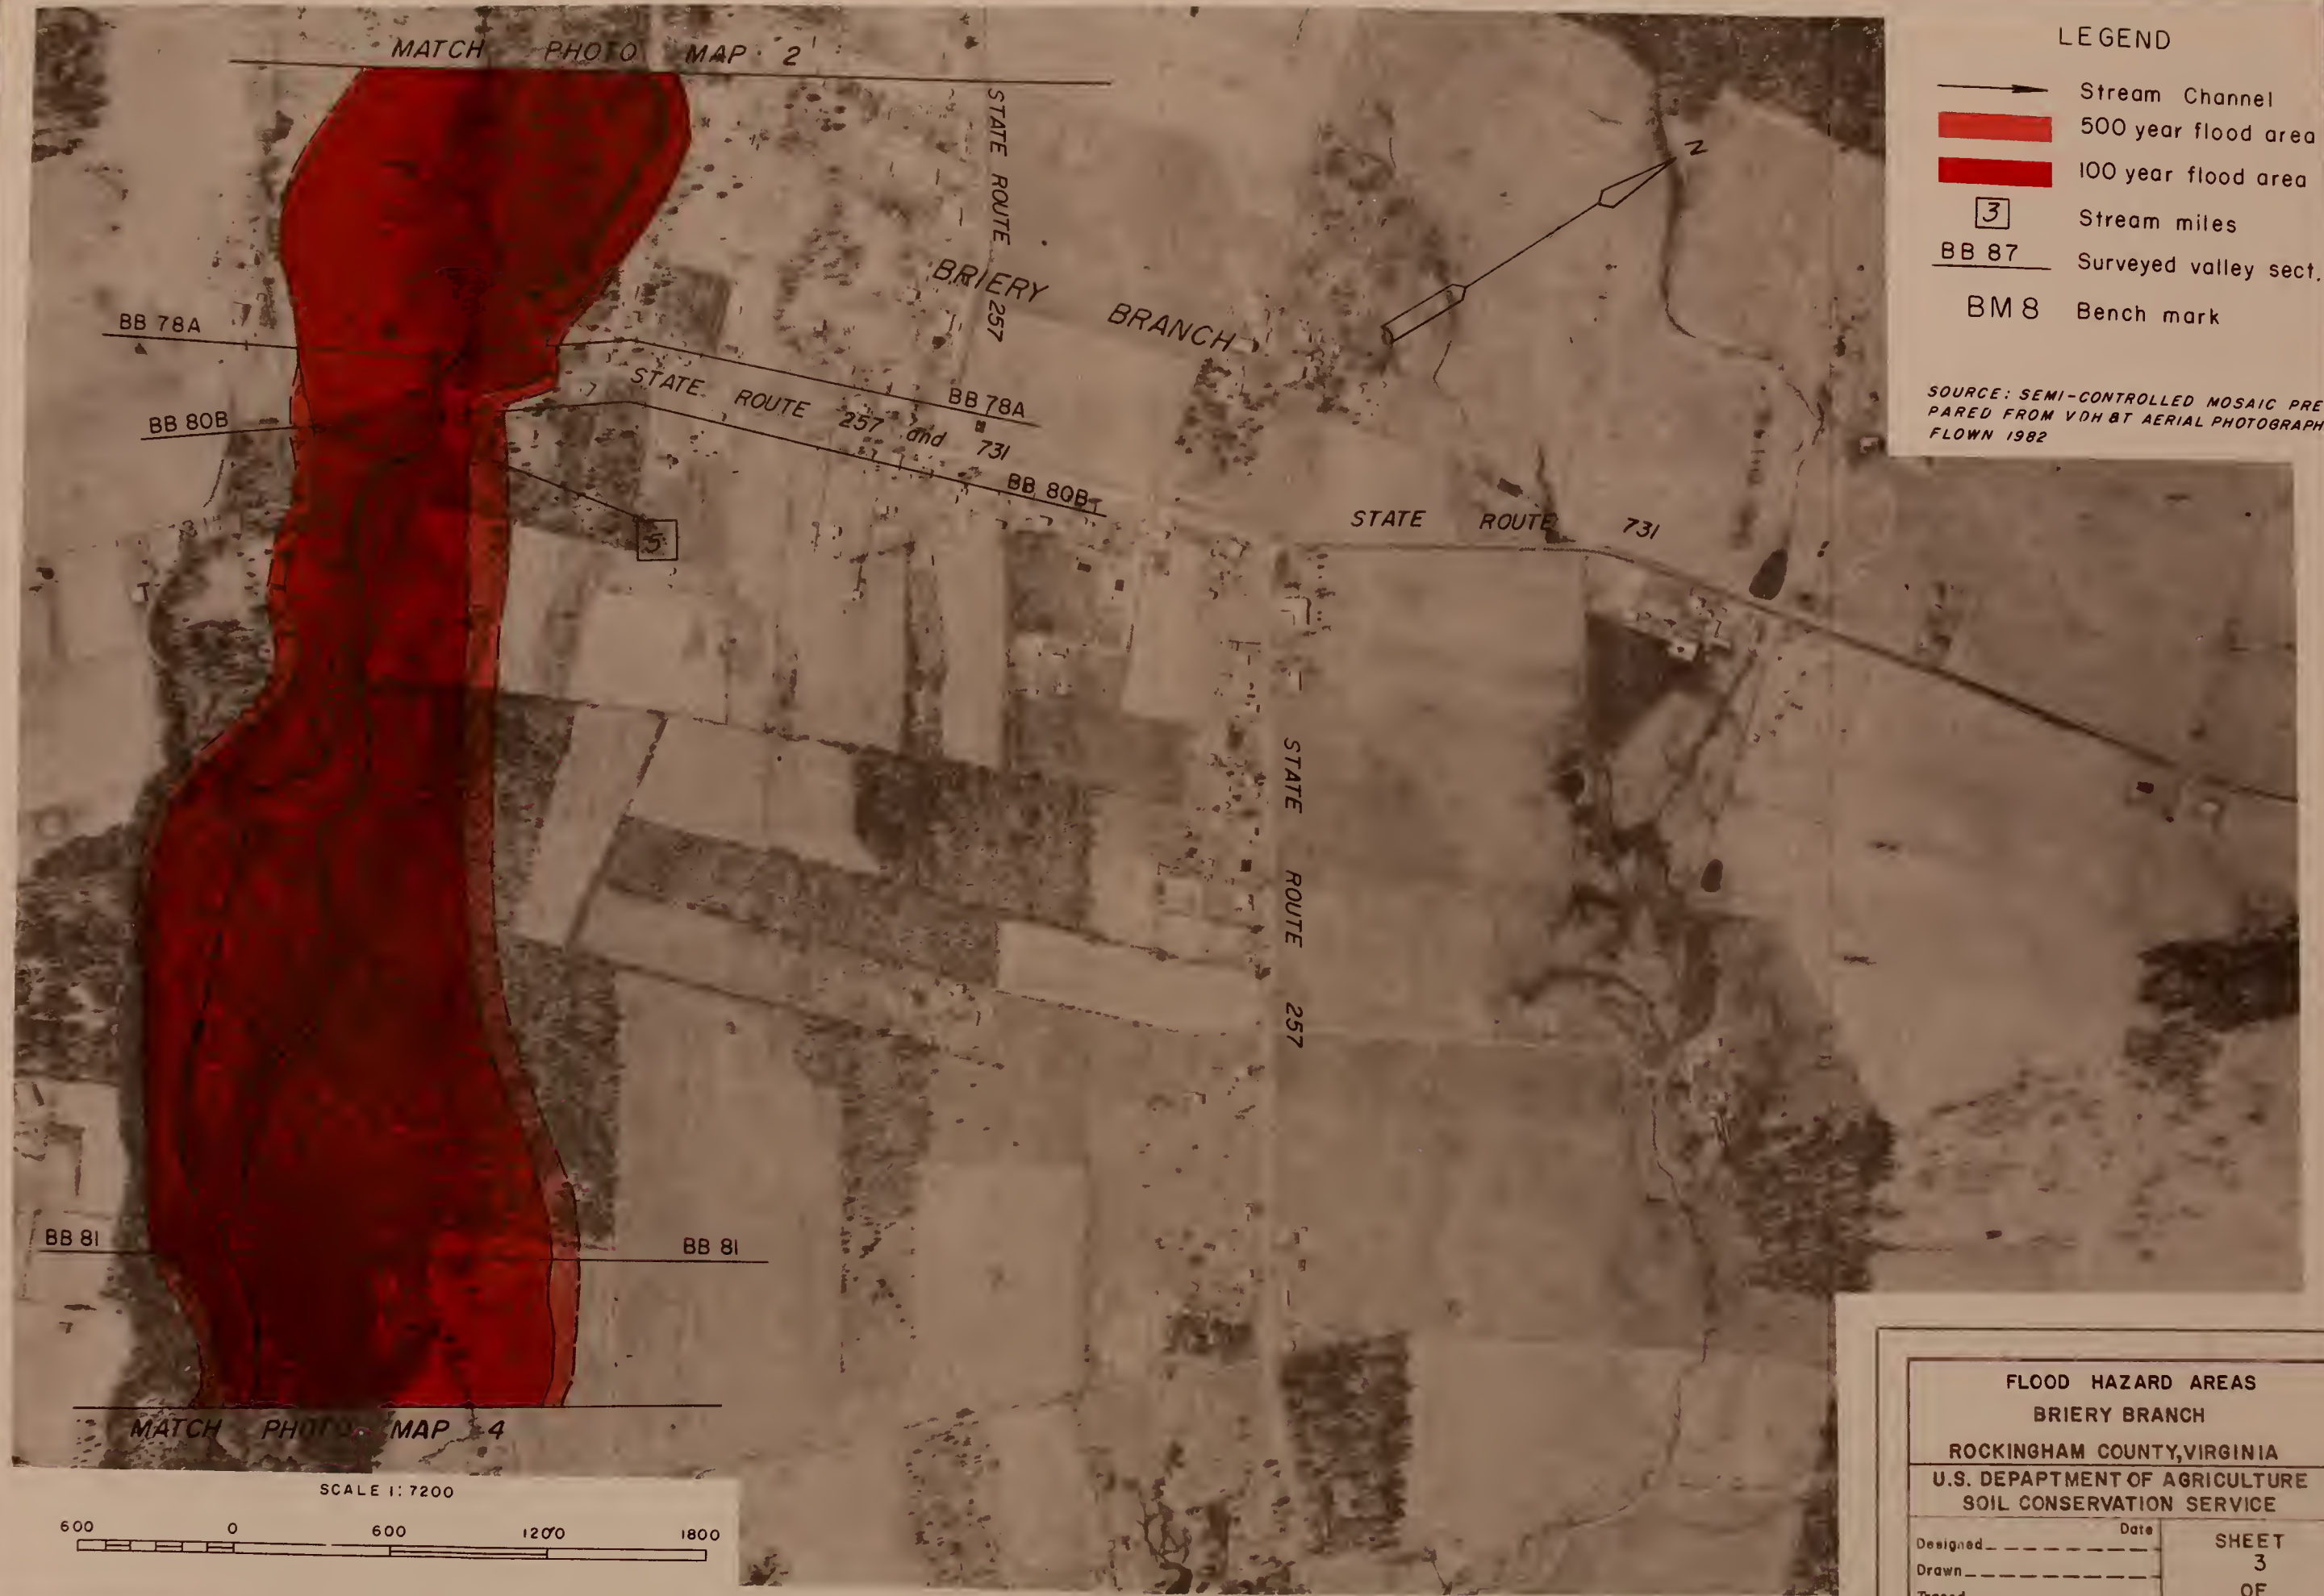
FLOOD HAZARD AREAS	
BRIERY BRANCH	
ROCKINGHAM COUNTY, VIRGINIA	
U.S. DEPARTMENT OF AGRICULTURE	
SOIL CONSERVATION SERVICE	
Dated _____	SHEET 2 OF 11
Drawn _____	
Traced _____	
Checked _____

SOURCE: SEMI-CONTROLLED MOSAIC PREPARED FROM VDH 8T AERIAL PHOTOGRAPHY FLOWN 1982

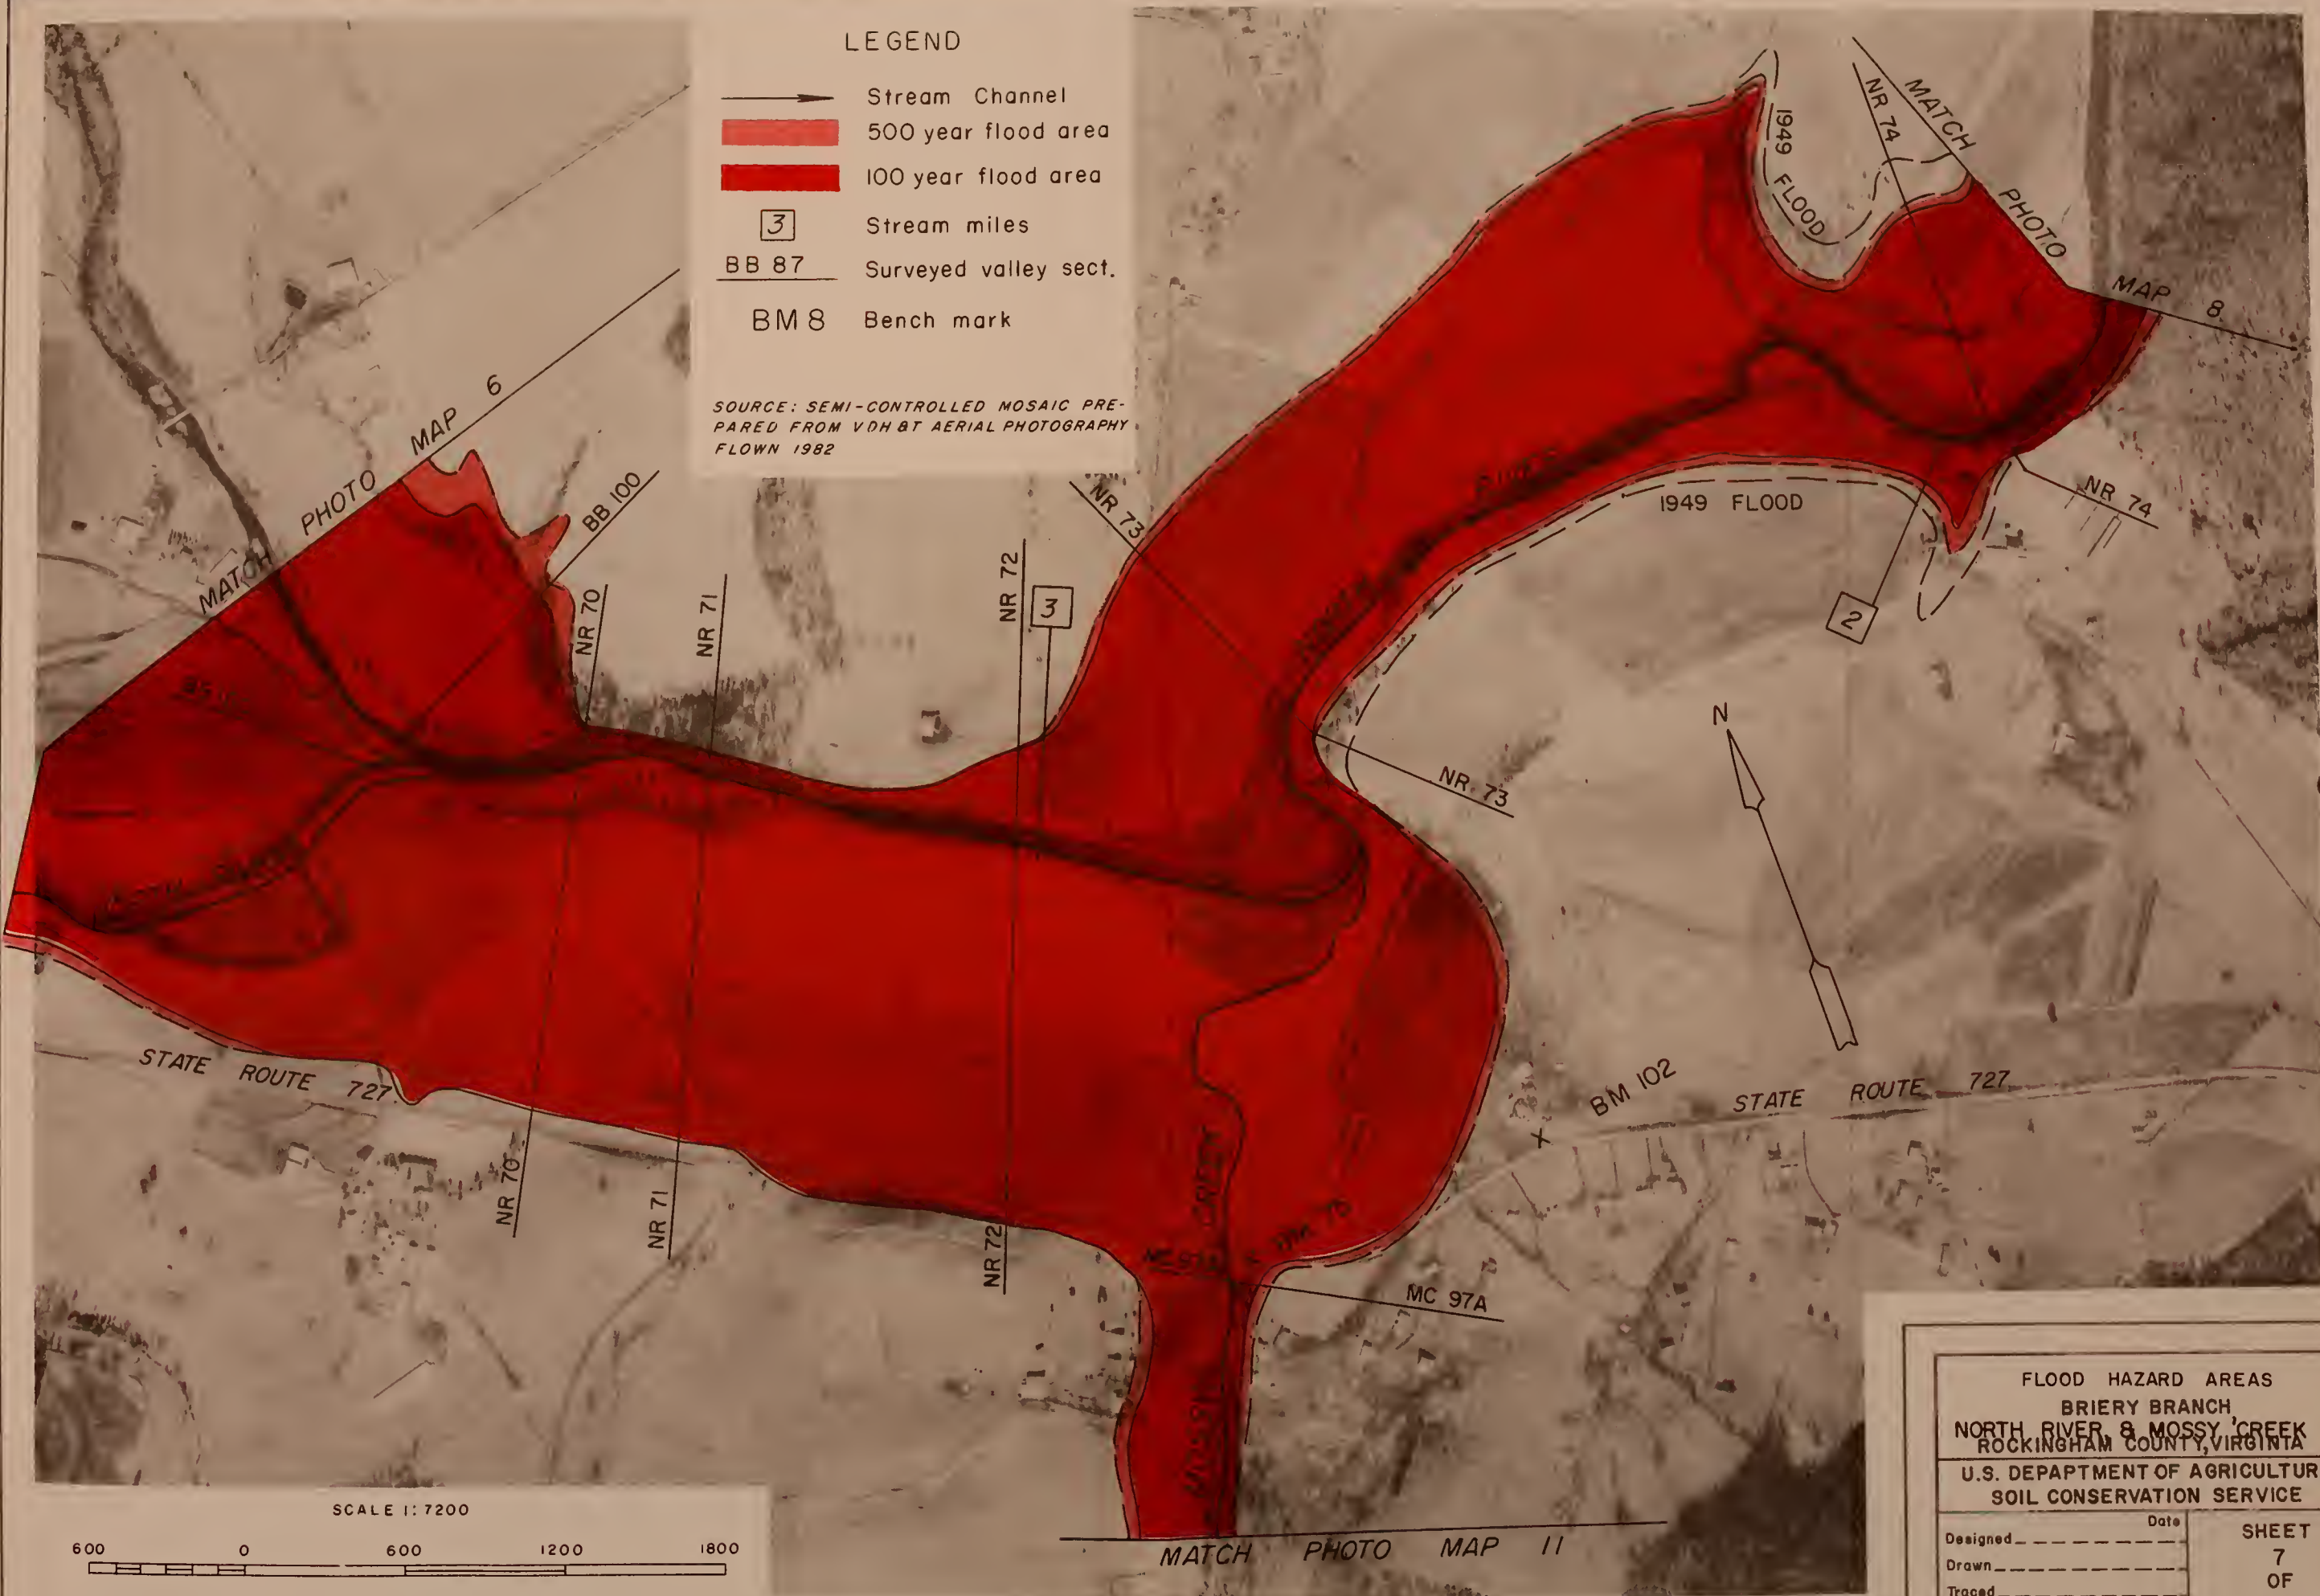
FLOOD HAZARD AREAS
BRIERY BRANCH
NORTH RIVER & MOSSY CREEK
ROCKINGHAM COUNTY, VIRGINIA
U.S. DEPARTMENT OF AGRICULTURE
SOIL CONSERVATION SERVICE

SOURCE: SEMI-CONTROLLED MOSAIC PREPARED FROM VDH AT AERIAL PHOTOGRAPHY FLOWN 1982

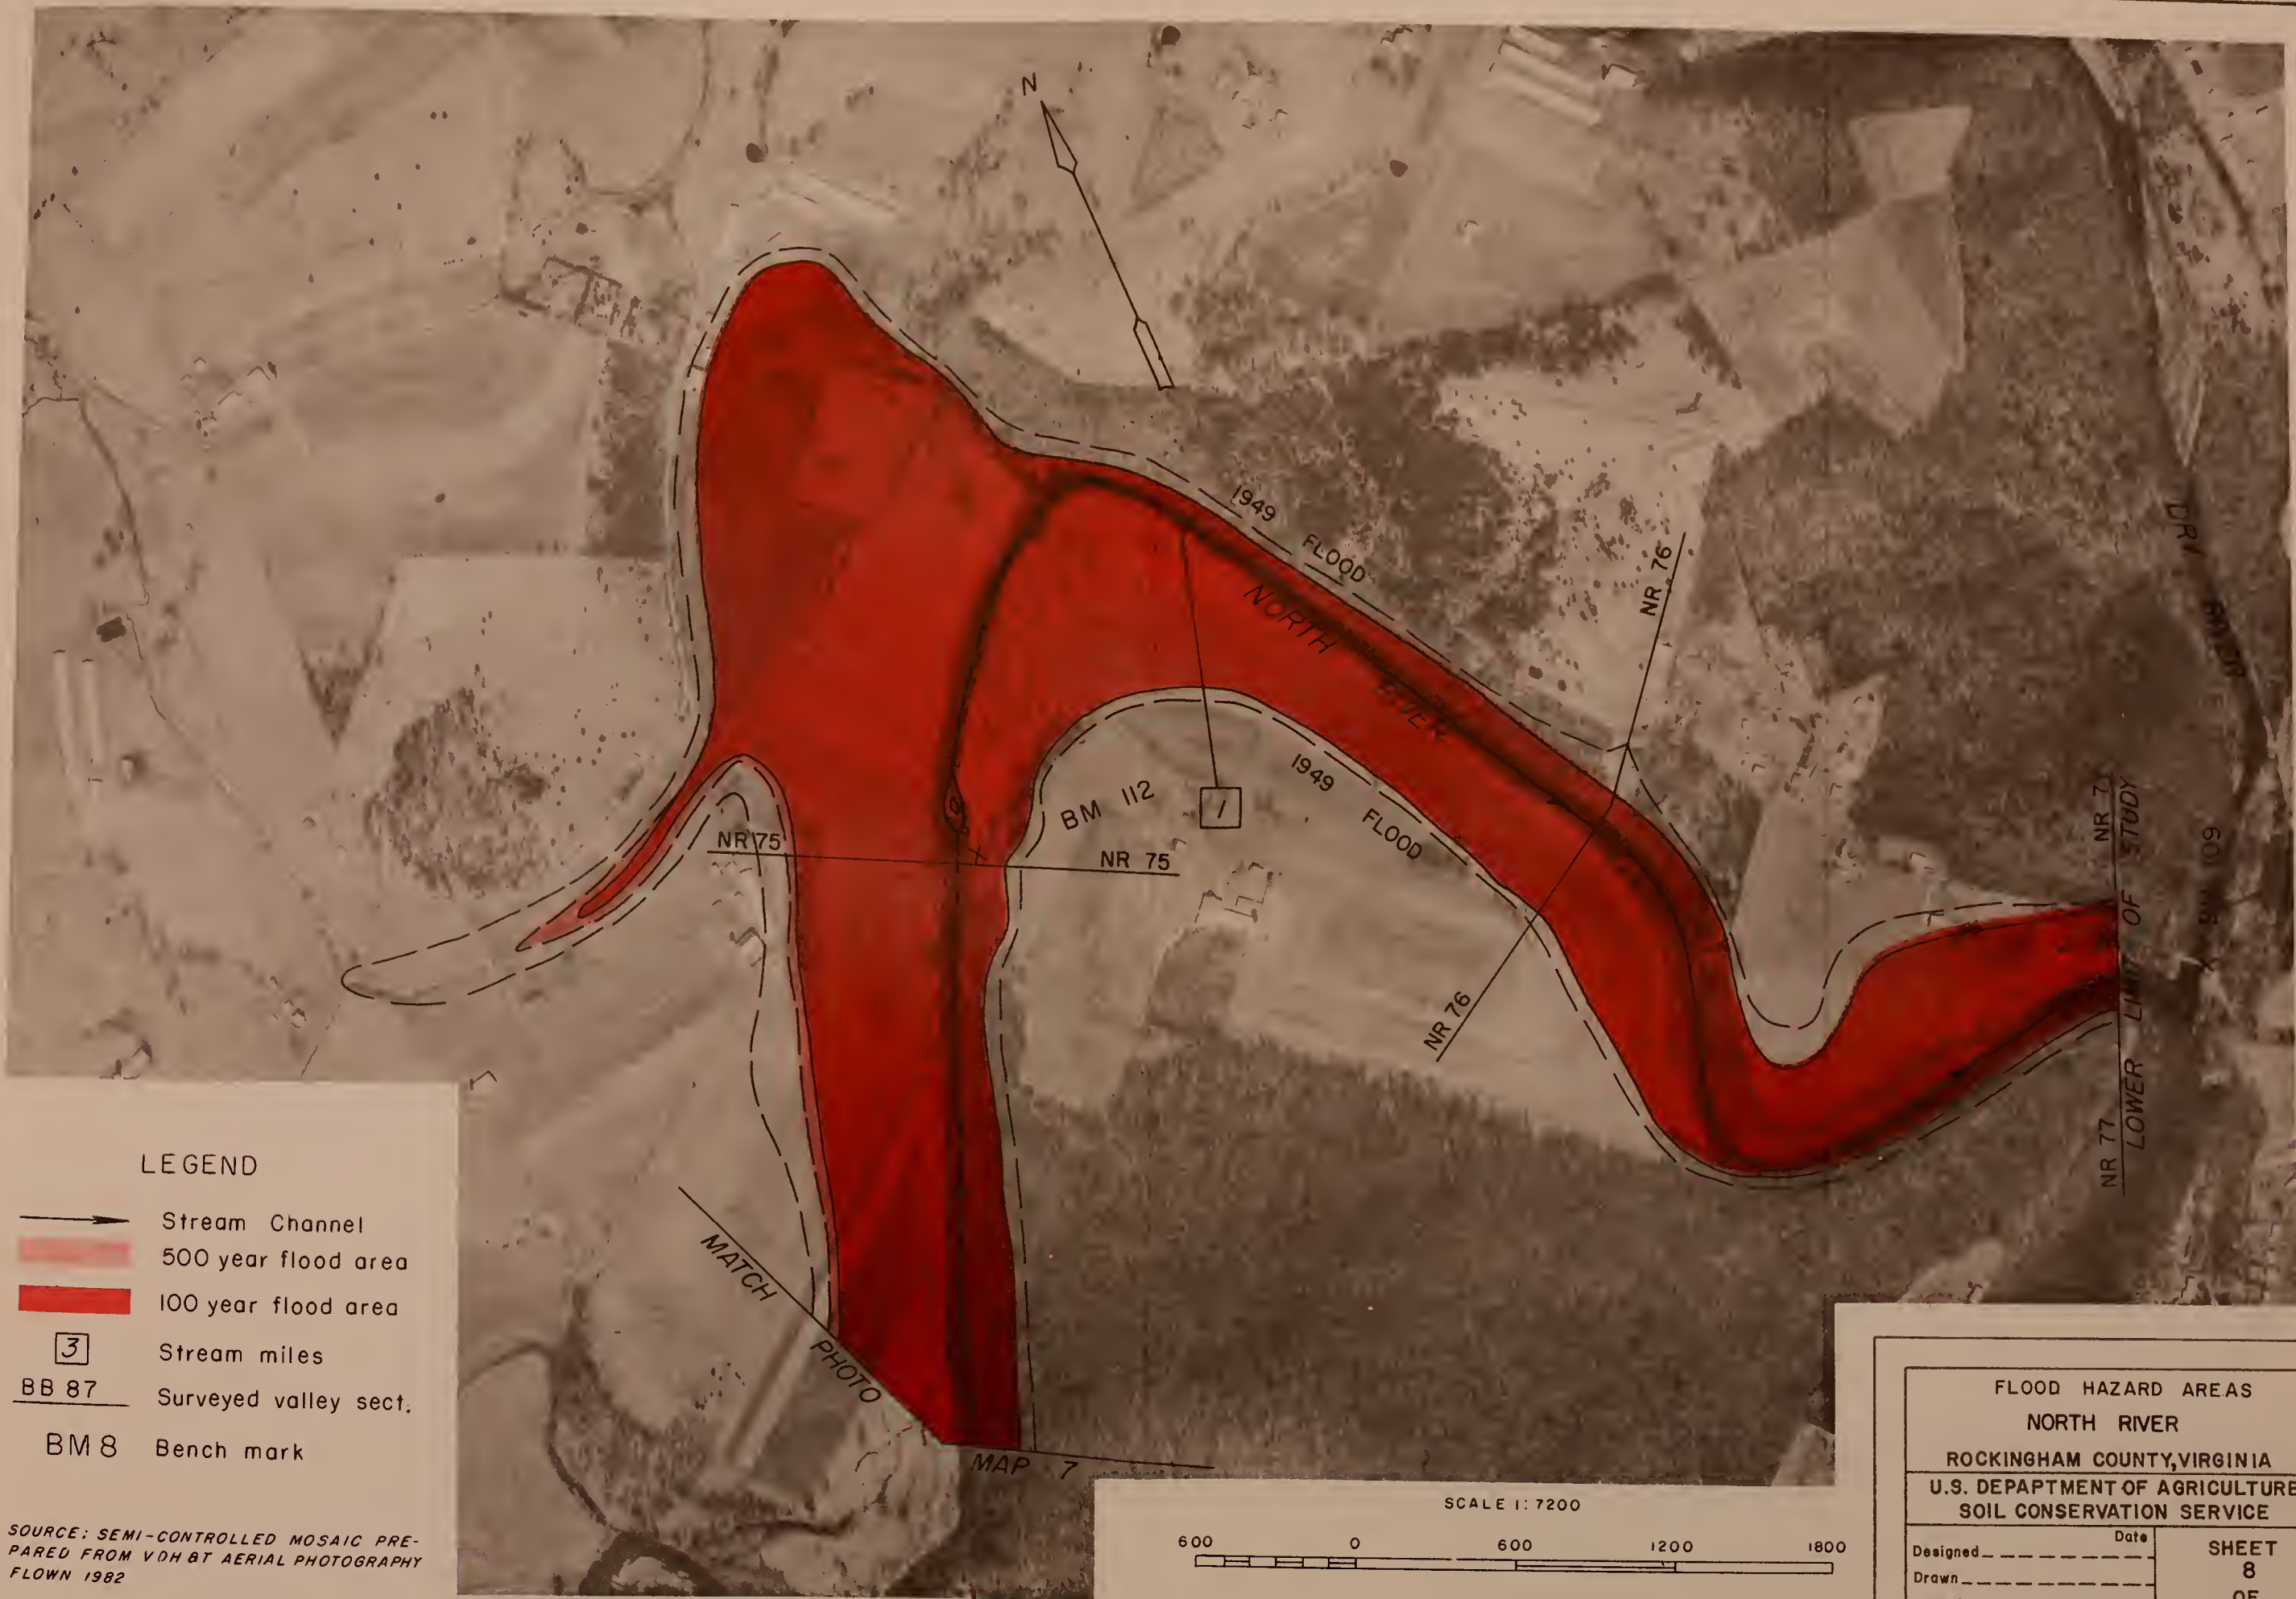
FLOOD HAZARD AREAS	
NORTH RIVER	
ROCKINGHAM COUNTY,VIRGINIA	
U.S. DEPARTMENT OF AGRICULTURE	
SOIL CONSERVATION SERVICE	
Designed _____	Date _____
Drawn _____	SHEET 8 OF 11
Traced _____	
Checked _____

SOURCE: SEMI-CONTROLLED MOSAIC PREPARED FROM VDH AT AERIAL PHOTOGRAPHY FLOWN 1982
